# SERVICE MANUAL

## INDEX EVEREST

*Version 3.0*

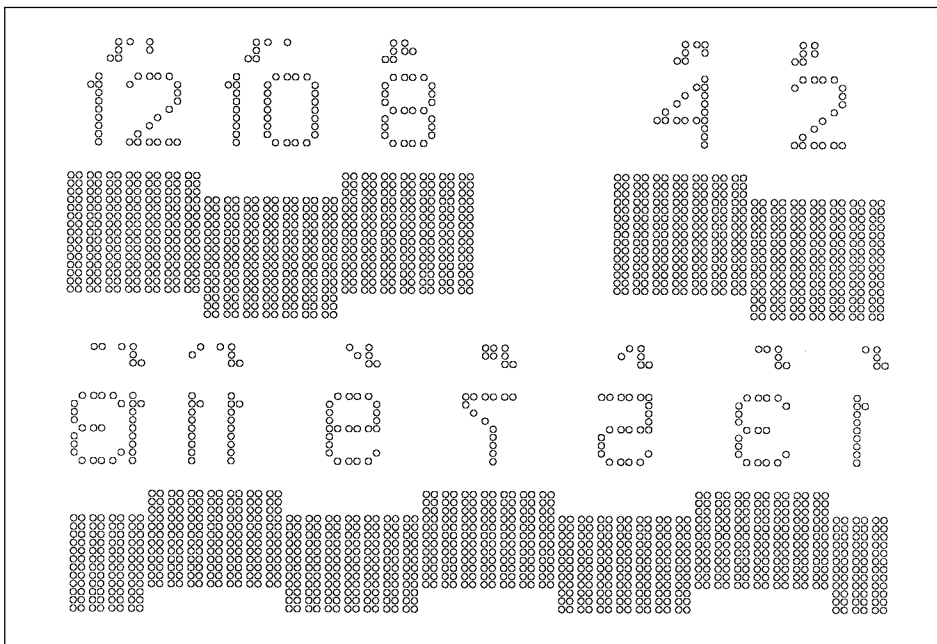
Picture B

If, for example, there is no print on block 6, (Picture B) test it in the following way;

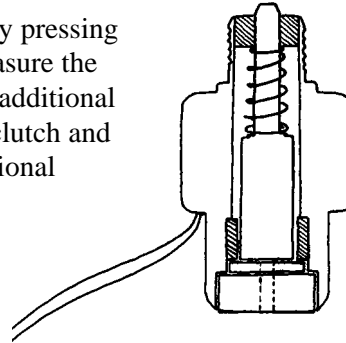
Check that the hammer plunge moving smoothly without friction by pressing an axle from the back hole of the hammer, movement 3.8 mm. Measure the resistance of the hammer, it should be 1.9-2.0 Ohm. If there is any additional friction on the plunge, clean the plunge of the hammer with a soft clutch and check the surface with peeling with your nails. If there still is additional friction it will be necessary to exchange the hammer.

*When the printing head is separated check that the tip of the anvil have a correct sphere form.*

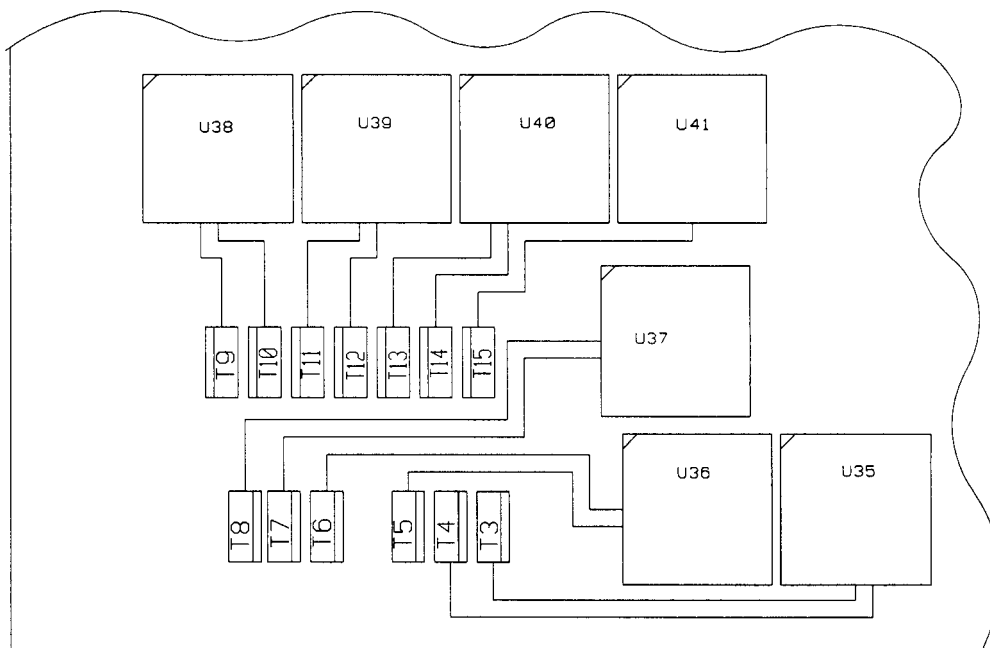
## Transistors

b) Check the resistance over the 13 power driving transistors (T3-T15 pin 1-3). The resistance shall be in the level 9-10 Kohm. A bad transistor normally indicates with a significant lower resistance. If this is the case exchange the transistor but be careful, it is a six layer board!

Our problem was on hammer six.

In below table you can see that it can be a result of driving circuit no U38.

For a fault on hammer 6 (our example) check the in signal (pin 24+24) and out signal (18+23). These pins shall be on a logic 0, (below 1,8 V) after power on of the unit. We do not recommend to check the FIFO and Buffer circuit as they are very sensitive and soldered on the board.

Hammer	Transistor MTP 3055E (x13)	Driving circuit UDN2916 (x7)	Buffert step (FIFO) 74AC843 (x2)
No:1 Negative	T12	U39 in 1+44 out 3+6	U32 out pin 22
No:2 Positive	T13	U40 in 24+25 out 18+23	U32 out pin 21
No:3 Negative	T14	U40 in 1+44 out 6+3	U32 out pin 20
No:4 Positive	T11	U39 in 24+25 out 18 +23	U32 out pin 23
No:5 Negative	T10	U38 in 1+44 out 3+6	U31 out pin 16
No:6 Positive	T9	U38 in 24+25 out 18+23	U31 out pin 17
No:7 Negative	T8	U37 in 1+44 out 3+6	U31 out pin 18
No:8 Positive	T6	U36 in 1+44 out 3+6	U31 out pin 20
No:9 Negative	T7	U37 in 24+25 out 18+23	U31 out pin 19
No:10 Positive	T3	U35 in 24+25 out 18+23	U31 out pin 23
No:11 Negative	T4	U35 in 1+44 out 3+6	U31 out pin 22
No:12 Positive	T5	U36 in 24+25 out 18+23	U31 out pin 21
No:13 Negative	T15	U41 in 24+25 out 18+23	U32 out pin 19

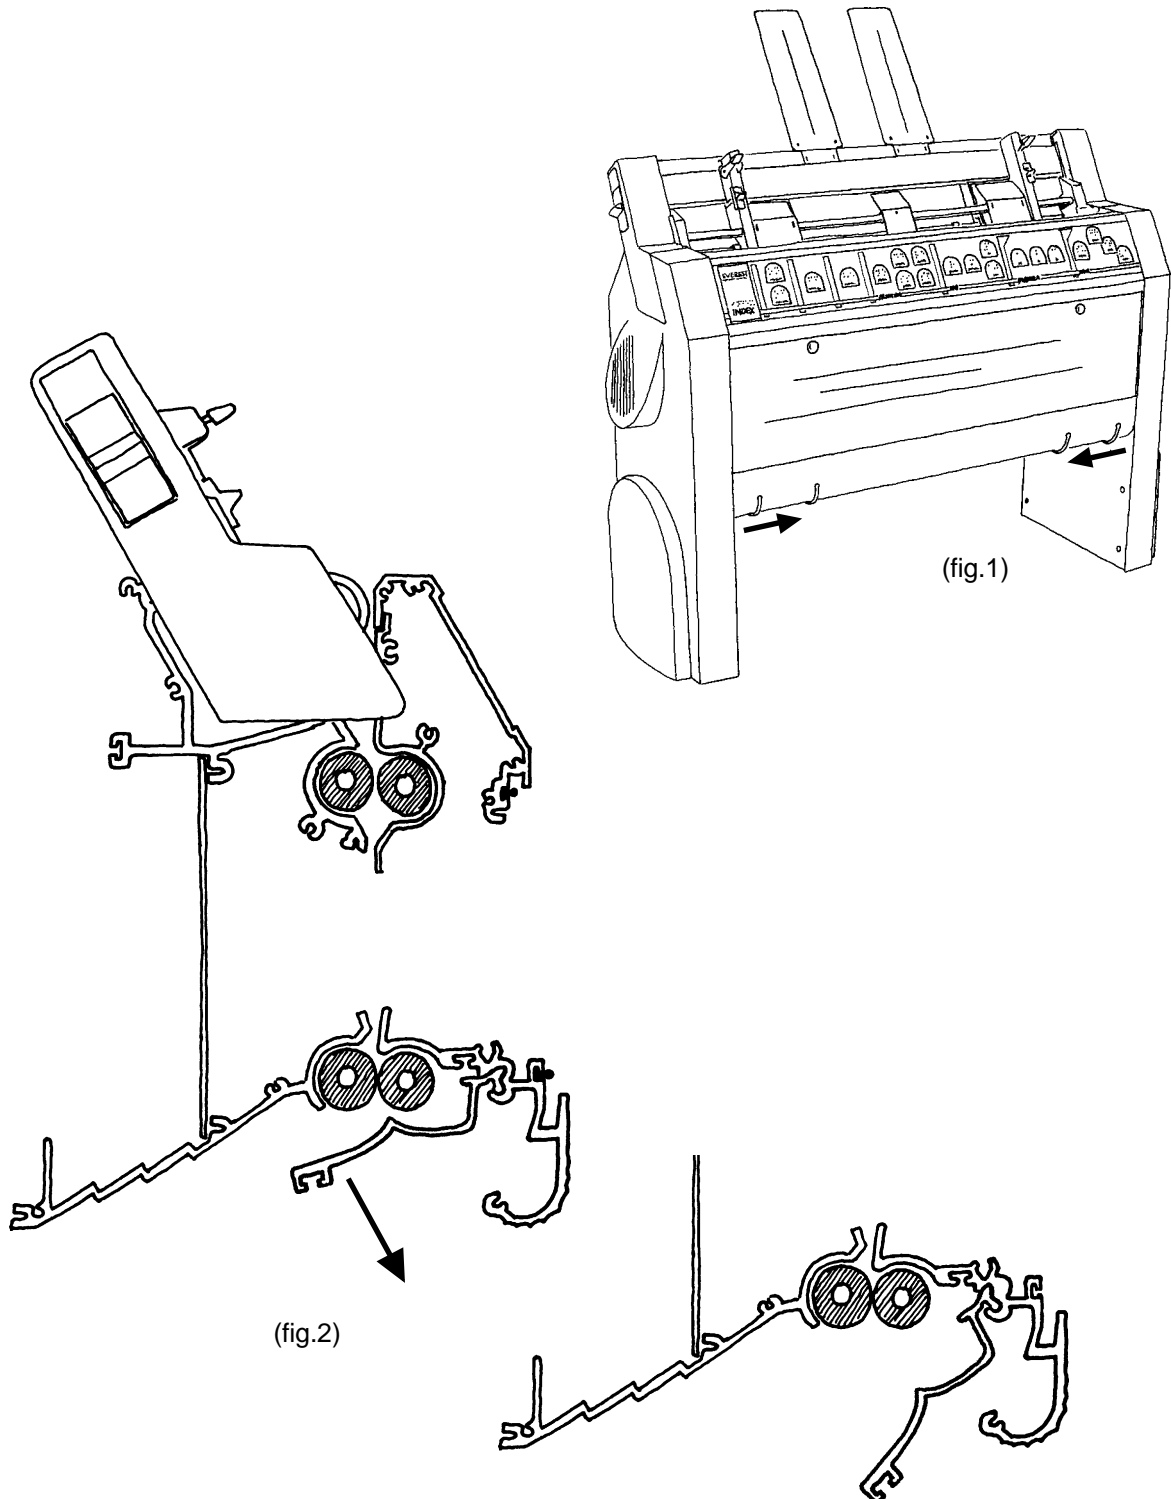
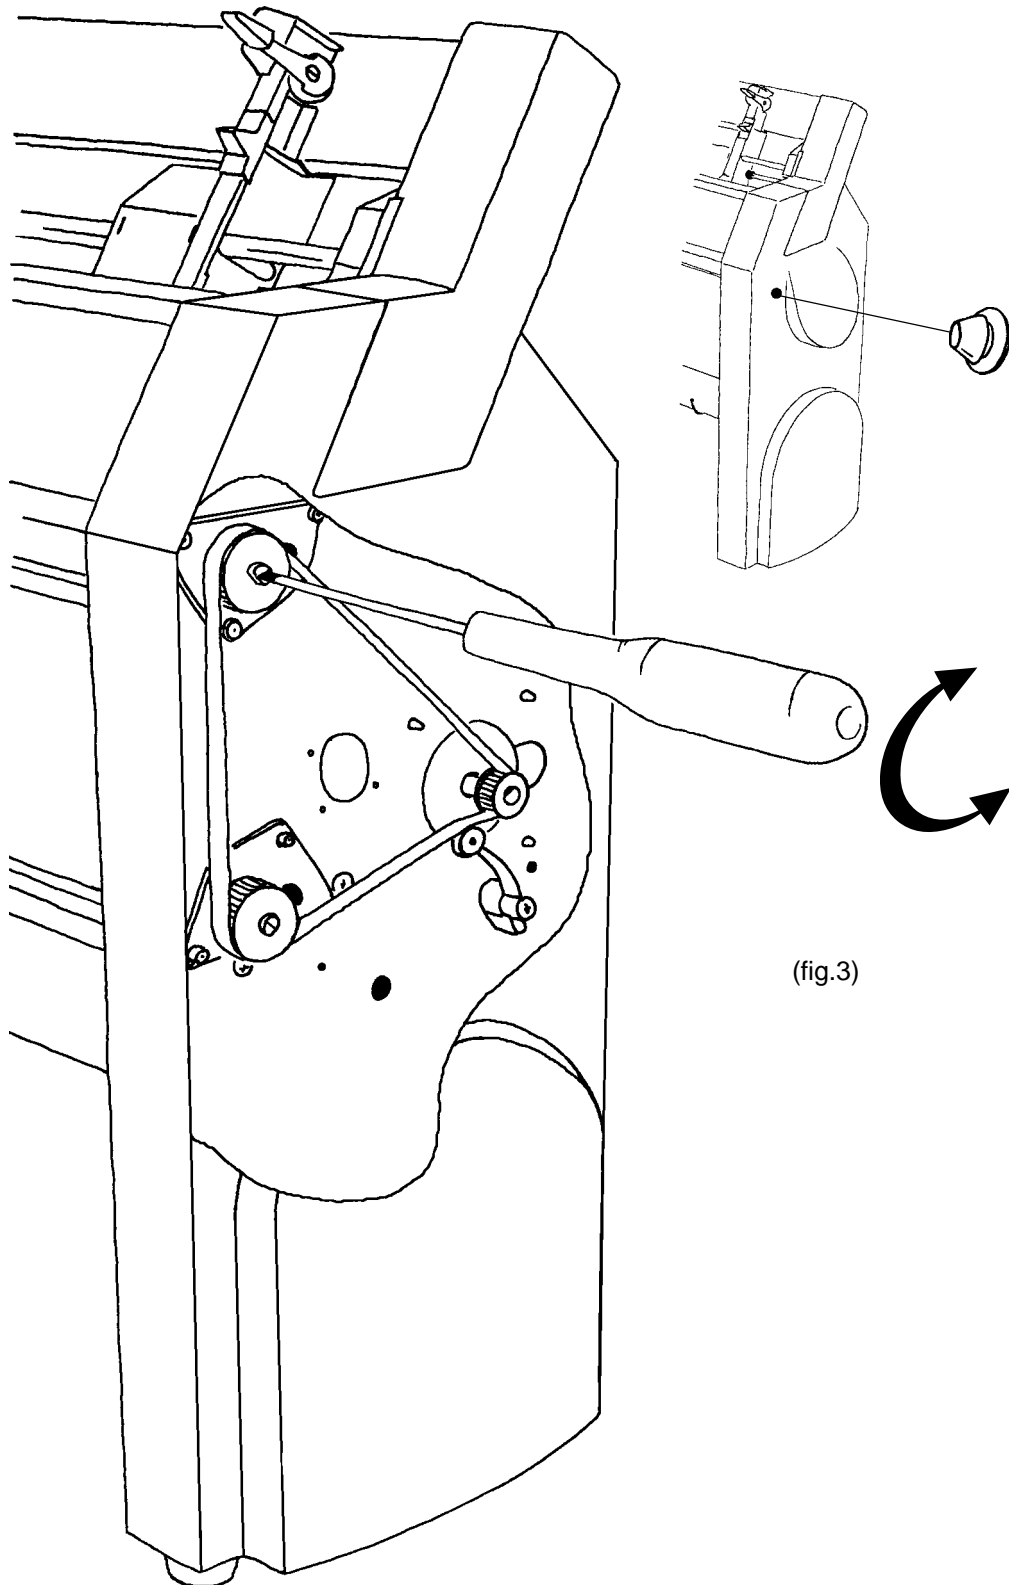
1. Remove the paper-stack
2. Check for paper at the top and under the printer
3. Open the bottom profile by sliding the lockers towards center (fig.1&2)
4. Remove cap on side cover and turn the rollers with a screwdriver (fig.3)

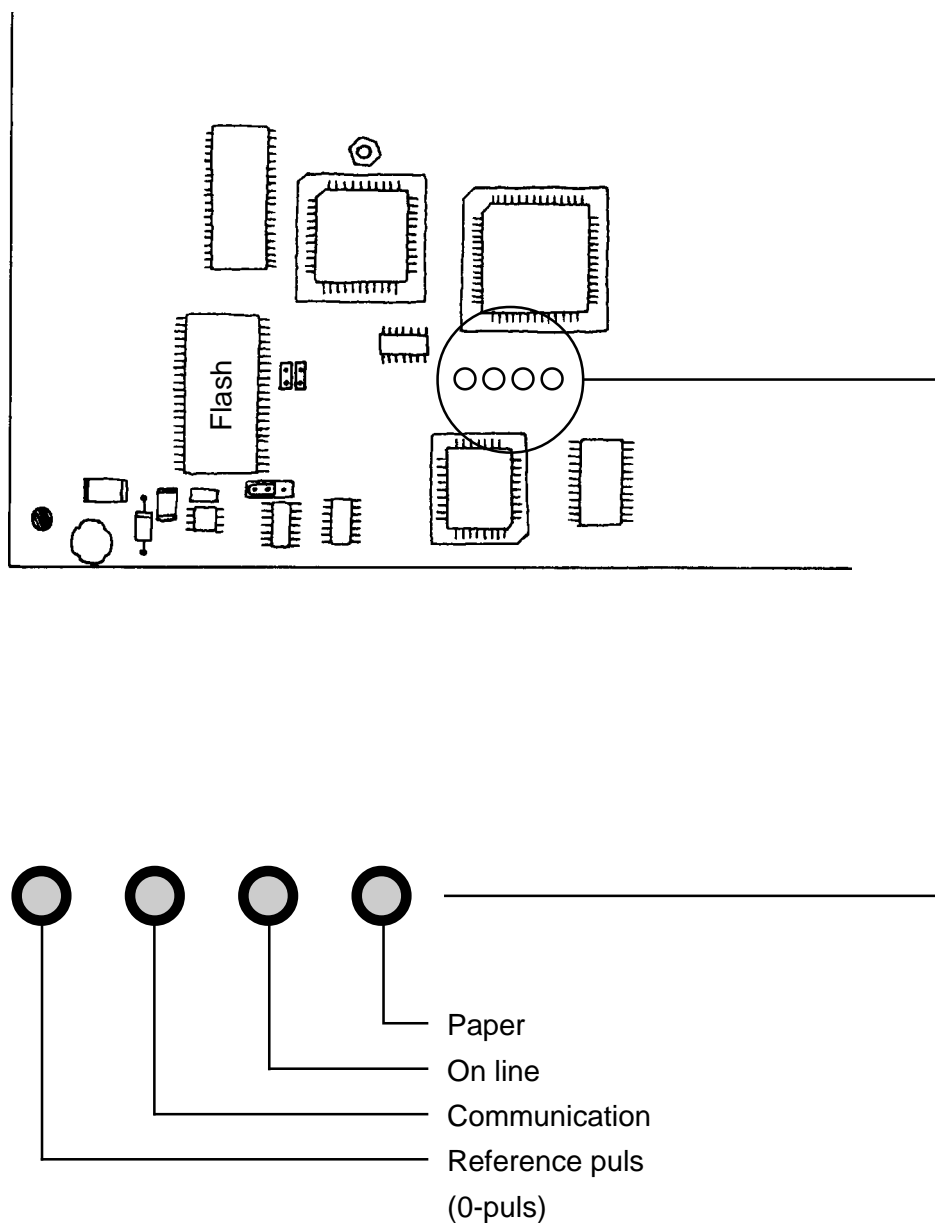
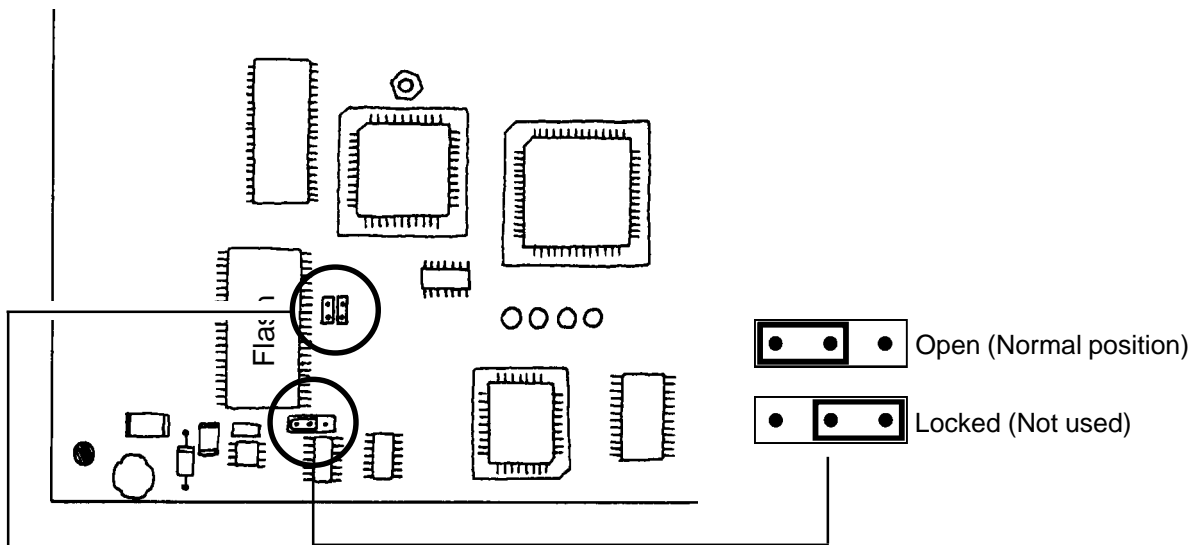
# LED indicator

*Load internal operation system and printer software...*

- 1 90° =
- 2 Power On Light (after 1 min)
- 3 Power Off
- 4 90° =
- 5 Power On (Ready for Programming)  
Pip, Piip, Piiip...  
Run installation software  
INSTALL NEW (5 min)
- 6 Power off
- 7 Power on + Group  
**-READY!**

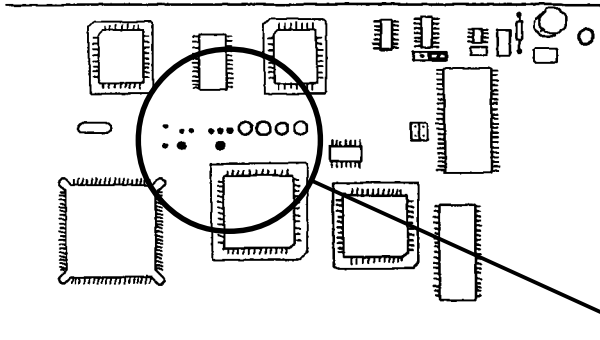
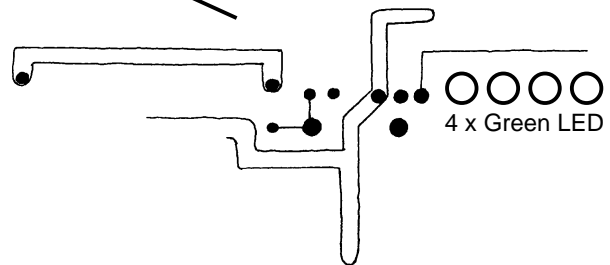
**If your Mainboard looks like this...**

Modification of the Everest Mainboard when connecting fan-backplate.

- Connect A & B with a wire.
- Connect C & D with a wire.
- Mount a 2pol pin connector at E.

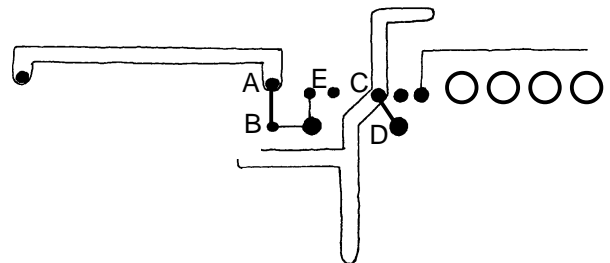
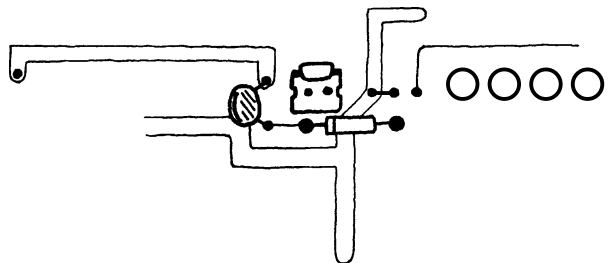
**If your Mainboard looks like this...**  
(and you want automatic fan-control)

- Mount BD 681

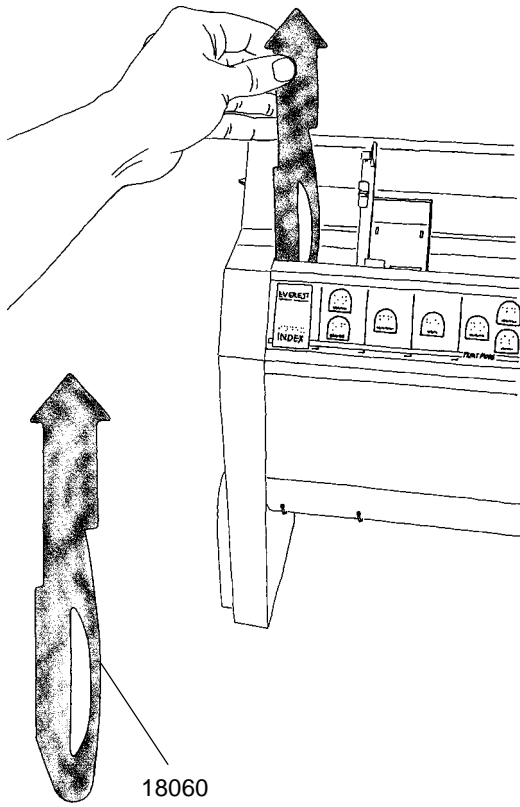
Always lock printinghead when shipping
